LOADLEASH: POTENTIAL OIL FITTING LEAKAGE

Cummins 6.7L ISB and Paccar PX-7 engines

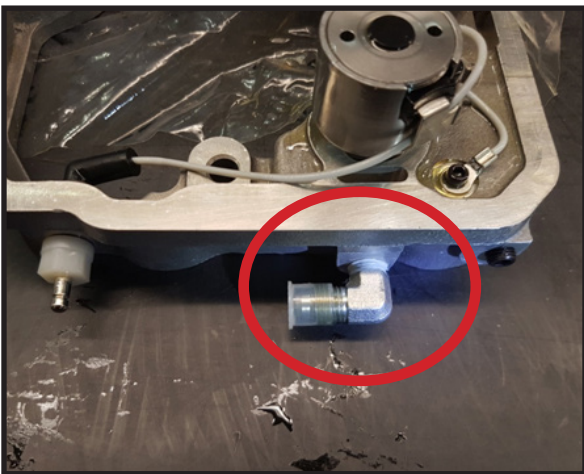
FIGURE 1:

The 1/8" NPT fitting of the oil feed has a leakage potential due to improper installation.

Affected Oil Port 1/8" NPT fitting.

It is imperative to immediately inspect the LoadLeash housing for potential cracks / oil leaks at the oil feed port of the housing.

Inspection of this oil feed port does not require removal of the LoadLeash housing, inspection may be accomplished using a mirror or borescope.

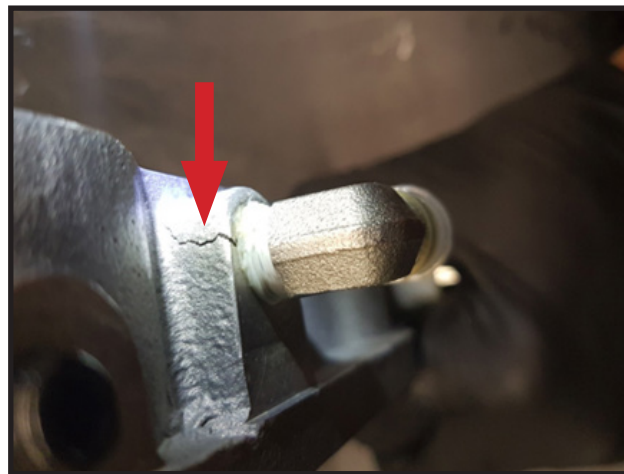
FIGURE 2:

The LoadLeash Engine Brake, installed on Cummins 6.7L ISB and Paccar PX-7 engines, have a potential oil leak issue due to over tightening of the 1/8" NPT oil feed fitting.

Over torqued 1/8" NPT fitting.

Please contact Pacbrake warranty department by phone: [800.663.0096](tel:800.663.0096) or email: warranty@pacbrake.com if you have a LoadLeash housing affected by this issue.
