## C20410 SERVICE PROCEDURE

**Subject:** C11300 Replacement Procedure  
Navistar #1893172C91

**Models Affected:** C20410  
Navistar #3006570C91

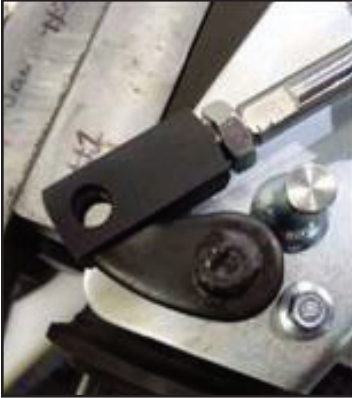
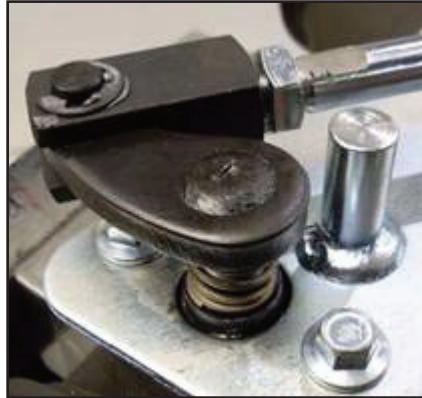
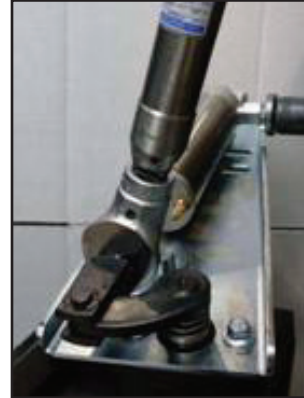
- 3 Apply anti-seize to the clevis pin and install through the clevis and through the butterfly arm, then install the remaining e-clip on the lower side of the clevis pin.

- 4 Using a 3/8" open end wrench on the cylinder rod, rotate the rod to extend the travel closing the butterfly. Once the butterfly becomes close to fully closed, move the clevis up and down on the butterfly arm while rotating the cylinder rod. Once the butterfly contacts the ID of the bore the clevis will no longer move freely up and down on the arm, at this point back off the adjustment slightly to achieve slight movement.
- 5 Tighten the lock nut to 25 ft-lbs (35 N•m). Re-check to ensure the adjustment is unchanged.
- 6 Install the original air inlet fitting into the assembly.
